SUMMARY REPORT

EPA Internal Review of the August 5, 2015 Gold King Mine Blowout 8/24/2015

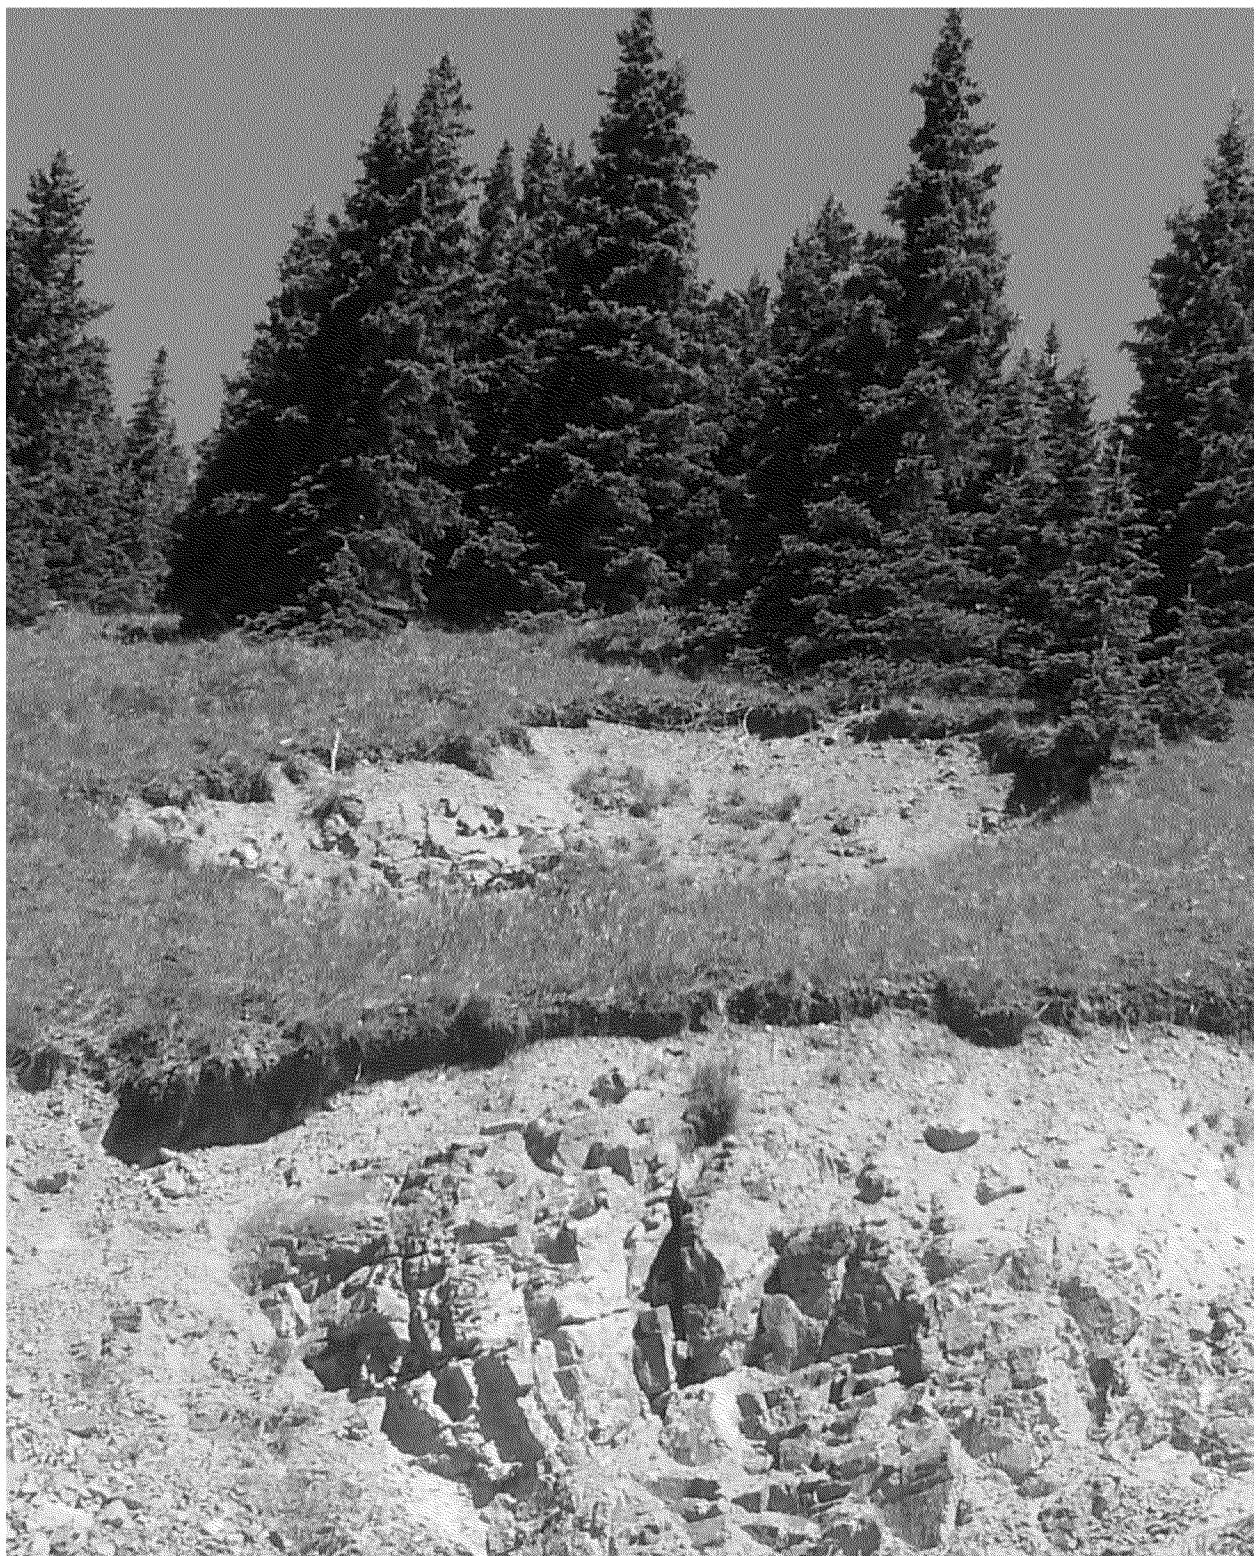
Photo 3 August 18, 2015 – Sink Hole and Slope above Gold King Mine Old Adit
